**Illuminate Home Inspections**

## Home Inspection Report

751 East 650 South  
Santaquin, UT 84655

Inspected on Sat, Jul 18, 2026 at 1:30 PM

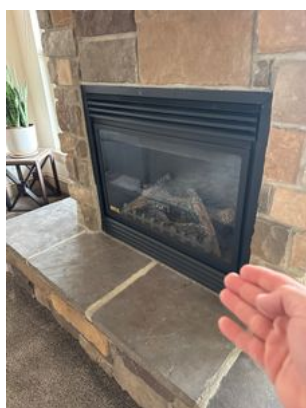
Fireplace was not operating with normal controls at the time of the inspection. Or remote is missing. Have the seller demonstrate that the fireplace is working.

Sometimes, the pilot or valve is turned off. The inspector does not relight pilots or turn on gas valves that are off for liability reasons.

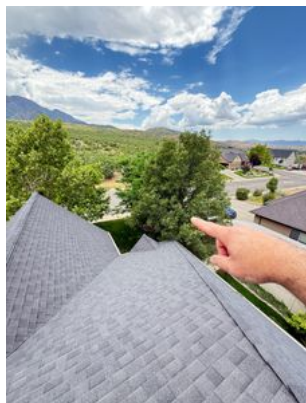
Trees with limbs contacting or overhanging the roof are recommended to be trimmed back or removed. Such conditions can allow pest access to the roof, increase the risk of roof damage from falling limbs, and contribute to gutter blockage from leaf debris.

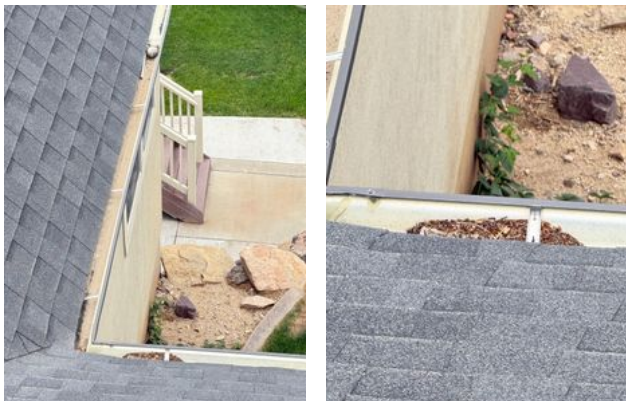
Defect: Debris observed in the gutters.

Implication: Debris in gutters hinders the flow and drainage of rainwater.

Recommendation: Cleaning the gutters is recommended.

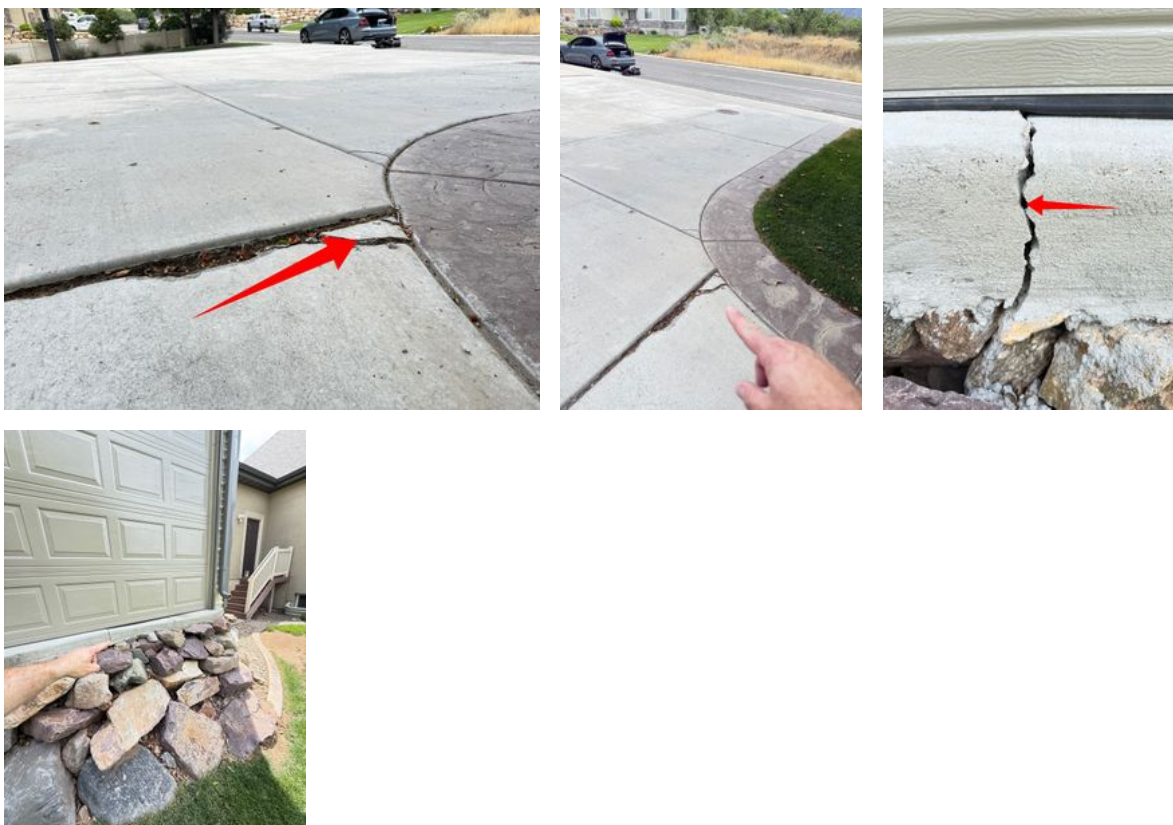
### Concrete Has Settled

Defect: Exterior concrete walkway sections, driveway, or entry steps have visibly settled, tilted, or shifted out of position.

Implication: Creates a distinct physical tripping hazard and can alter exterior surface water runoff vectors back toward the foundation.

Recommendation: Recommend a concrete lifting specialist stabilize and raise the slabs via poly-jacking or mud-jacking.

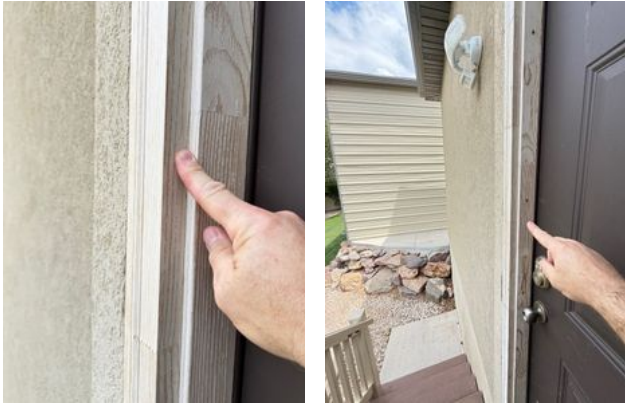
Worn paint (or worn stain) observed.

Paint protects and prolongs the life of the wood, metal and/or structure.

Sanding and repainting all worn areas is recommended.

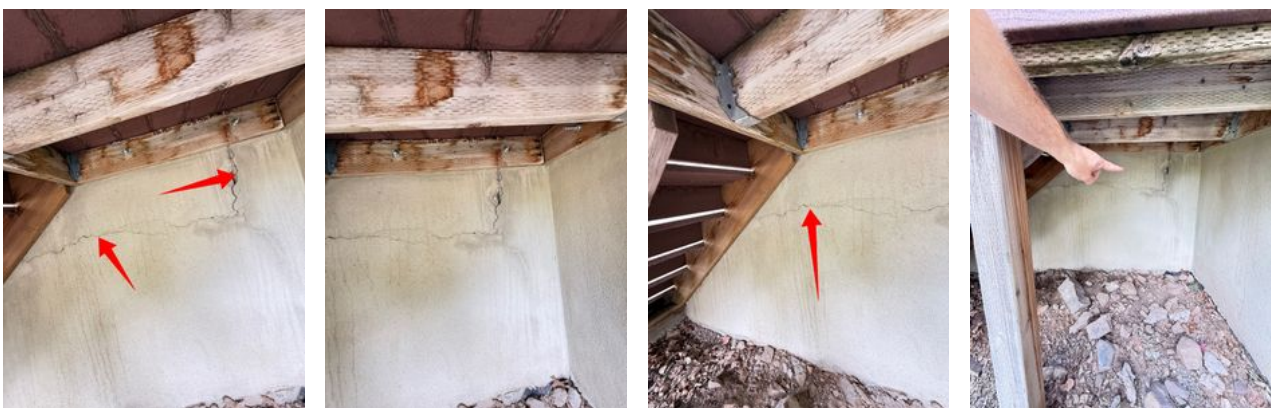
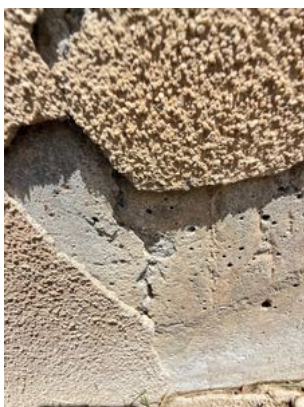
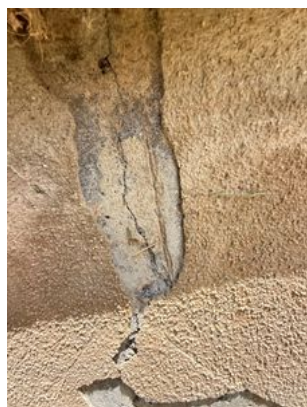
Hairline to moderate cracks were observed in the foundation wall.

Cracks may be superficial or extend through the foundation and are not necessarily structural; however, they may be associated with settling, material movement, or drying. Cracks can also allow water intrusion, which may lead to further damage.

Further evaluation by a qualified concrete or foundation contractor is recommended. Repairs may include sealing or epoxy injection, as appropriate.

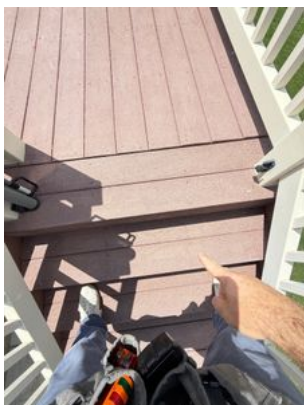
The staircase assembly was loose and wobbles from side to side. Additionally, no joist hangers or approved structural fasteners are present where the stair stringers meet the upper framing.

This indicates inadequate structural attachment and lateral support, presenting a severe fall and collapse hazard.

Recommend immediate evaluation and repair by a licensed framing contractor to properly secure the staircase.

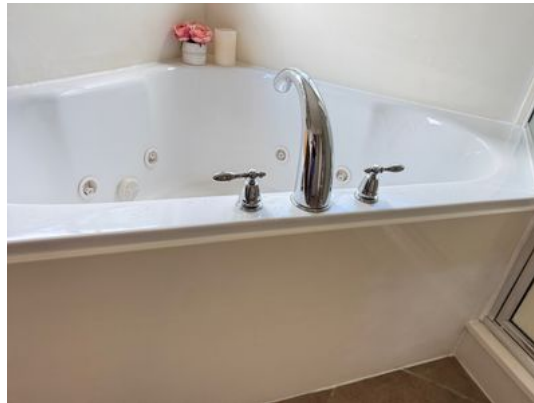
Defect: Running multiple plumbing fixtures simultaneously results in a drop in operational water pressure and flow.

Implication: Indicates underlying issues such as undersized main water lines, heavily corroded/scaled galvanized piping, a failing pressure regulator (PRV), or a partially closed water main valve.

Recommendation: Recommend a licensed plumber inspect the incoming supply loop and verify system pressure.

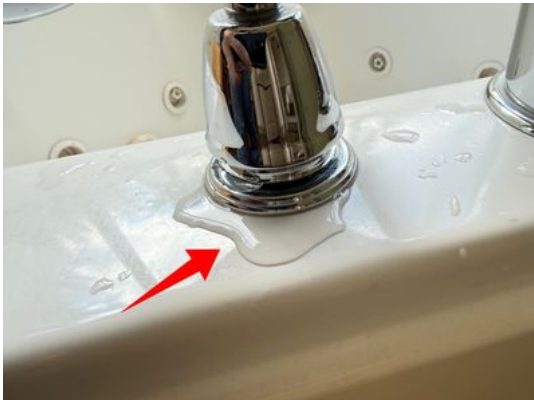
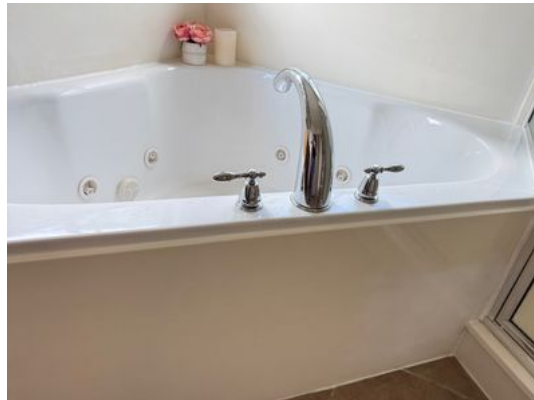
### Plumbing Leak / Drip

Defect: One or more plumbing fixtures exhibited a drip from the spout or handle base.

Implication: Causes ongoing water waste and can lead to finish staining or cabinet rot if left uncorrected.

Recommendation: Recommend a handyman or plumber rebuild the internal valve washers or replace the faucet fixture assembly. Further evaluation by a licensed plumber is recommended.

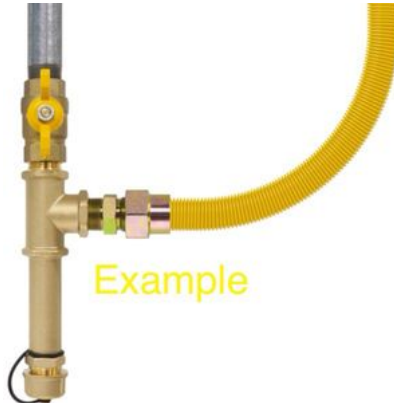
### Gas Supply Line Missing Sediment Trap

Defect: No vertical plumbing sediment trap (drip leg assembly) is provided on the rigid gas supply pipe line right before it terminates at the appliance gas valve.

Implication: Violates standard gas codes. Fails to catch moisture condensation, pipe scale, and black iron manufacturing debris before it travels into the sensitive automated gas control valves, jamming them open or closed.

Recommendation: Recommend a licensed plumber or HVAC technician retrofit a standard tee-and-cap sediment trap on the appliance gas feed line.

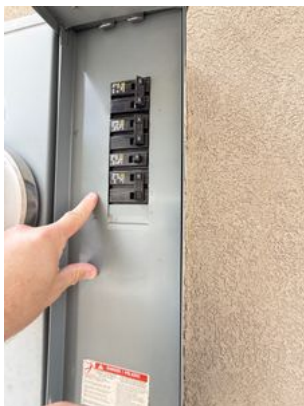
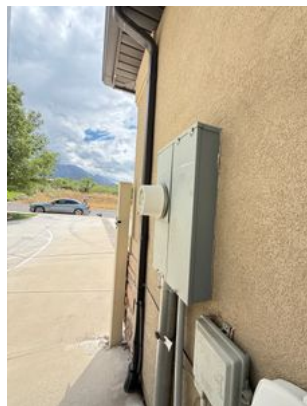
### Panel Labeling Inadequate

Defect: Circuit breakers inside the main panel or subpanels were unlabelled, illegible, or incorrectly mapped.

Labels should indicate if there are meant for kitchen/bath outlets or lights instead of a generic “kitchen” or “bath.” Ex. Kitchen receptacles require 20A breaker, as where kitchen lights only require 15A breaker.

Recommendation: Recommend identifying, testing, and permanently labeling all circuit breaker positions.

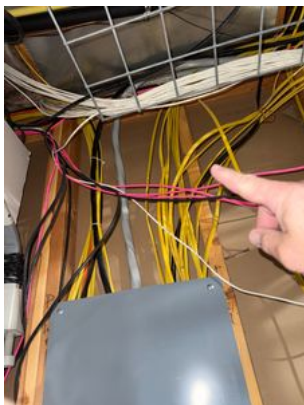
Wires from a panel were not secured within 12 inches of the panel.

Correction by a licensed electrician is recommended.

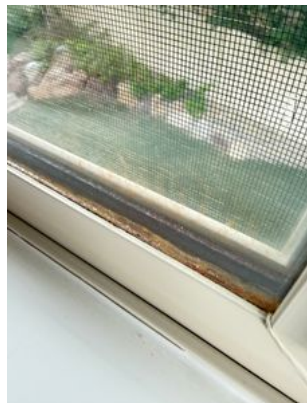
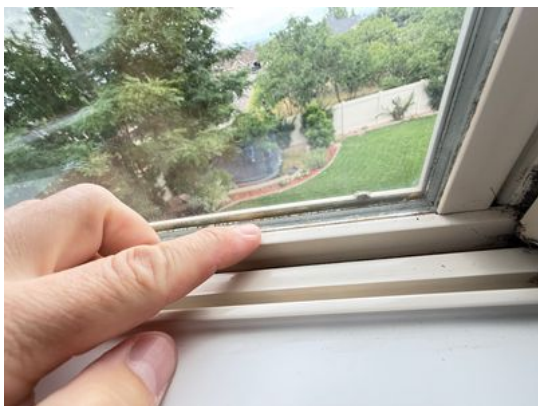
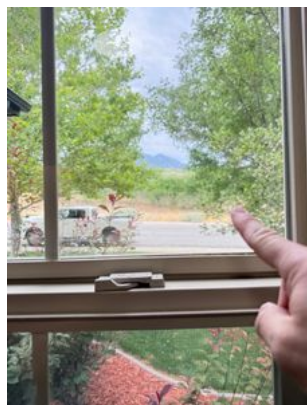
The weather seal at the window was broken. Broken seal or moisture between the panes.

This can affect the home's energy efficiency. It can also potentially cause moisture to seep into the structure of the home.

Have a qualified specialist evaluate and seal the gap to ensure a weather-tight finish.

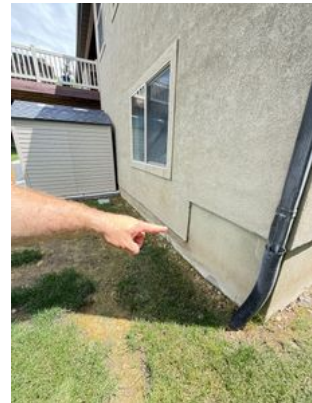
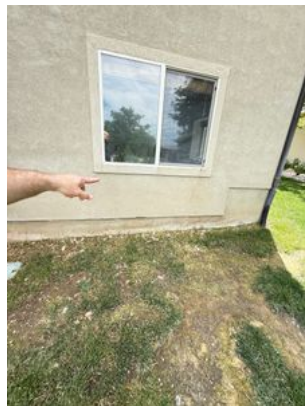
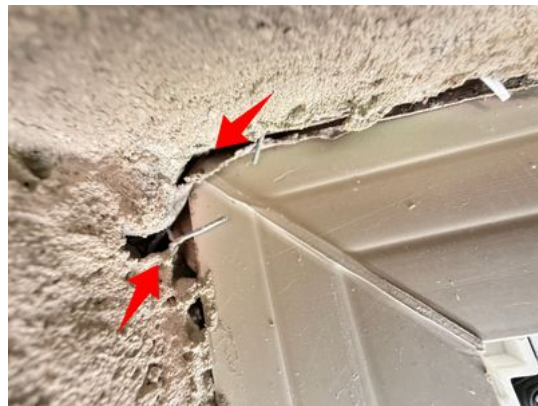
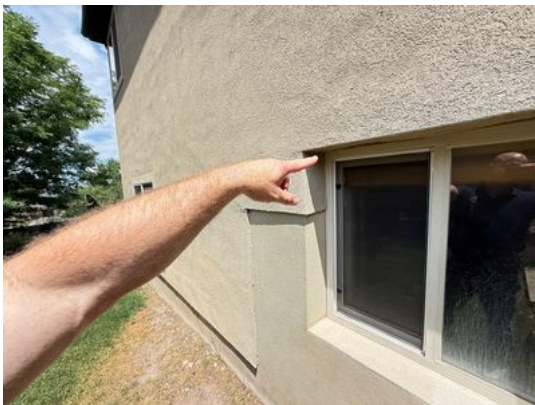
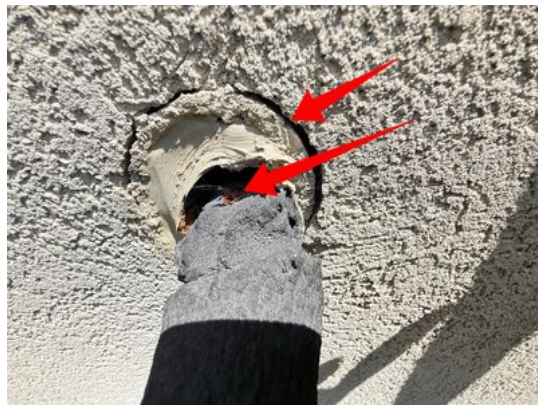
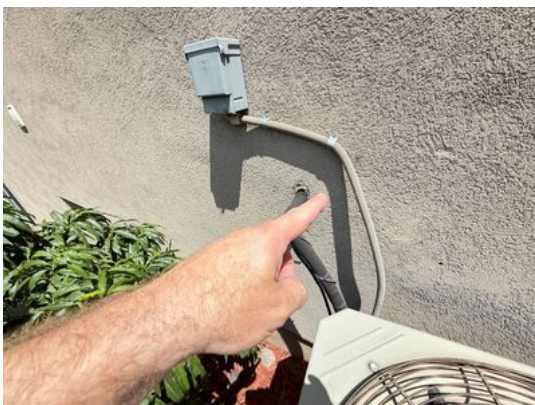
Small to moderate gaps were observed on the exterior of the home.

These gaps can allow moisture, pests, and debris to enter. Cracks are not necessarily structural defects.

The proper sealing of all cracks and gaps on the exterior is recommended.

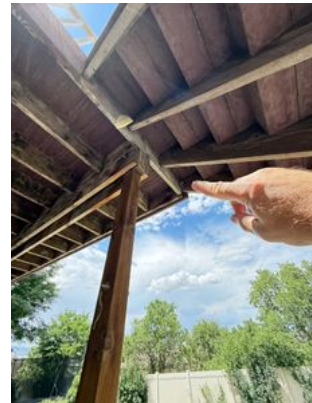
#### Missing Joist Hanger Fasteners or Wrong Kind of Fasteners

Defect: Deck joist hangers are installed using unapproved structural screws, missing double-shear angled fasteners, or have empty pre-punched holes.

Implication: Non-approved fasteners lack the necessary shear strength. Under heavy live loads (like snow or gatherings), the joists can shear off the ledger board, causing total deck collapse.

Recommendation: HIGH PRIORITY: Require a licensed contractor to replace all improper fasteners with manufacturer-approved connector screws (e.g., Simpson Strong-Drive SD) or hot-dip galvanized common nails.

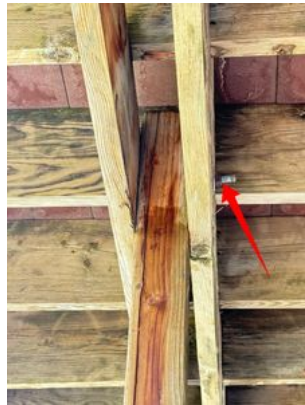
1. Observation: The main deck framing (rim joist/beam) is currently flush-bolted to the sides of the vertical support posts rather than resting directly on top of them. This creates a condition where the entire structural load of the deck relies purely on the shear strength of the fasteners (bolts) rather than direct, gravity-loaded bearing on the posts.

2. 4 x 4 posts were used to support the deck. The deck appeared to be a little taller than 8 feet, in which case 6 x 6 posts, would be the standard. In addition, one of the posts was bowed. It is recommended to have this deck evaluated by a deck specialist and repaired.

**Recommendation:** A qualified licensed contractor should evaluate the structure and install approved post-to-beam connectors, structural brackets, or vertical jack studs (shims/blocks) to ensure positive, direct load transfer from the deck framing down to the footings.

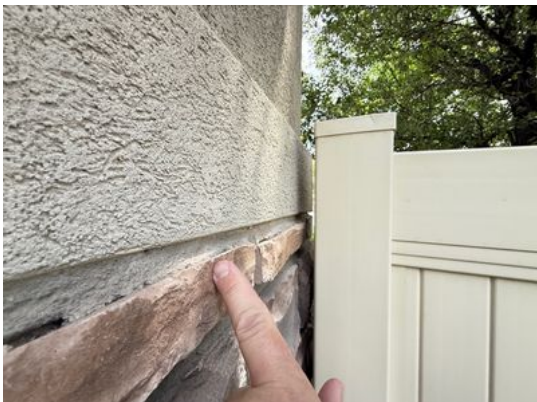
#### Z-Flashing Missing for Transition of Two Different Siding Materials

**Defect:** No metal Z-flashing or drip cap is installed at the horizontal material transition joint between the upper siding and lower siding.

**Implication:** The joint relies solely on sealant caulking, which degrades over time. Water will bypass the seal and run directly behind the lower siding, rotting the structural wall studs.

**Recommendation:** HIGH PRIORITY: Recommend a qualified siding contractor retro-fit an integrated metal drip cap flashing into the building wrap barrier. There should be flashing when two different types of siding meet.

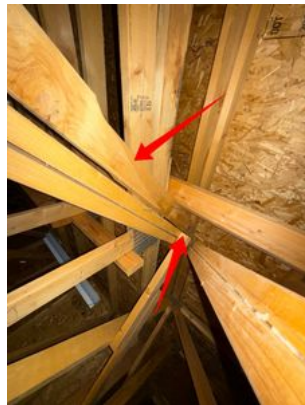
Defect: A structural roof truss or rafter has been cut, split, or modified.

Recommendation: HIGH PRIORITY: Recommend evaluation and structural repair by a licensed framing contractor or according to an engineer's design.

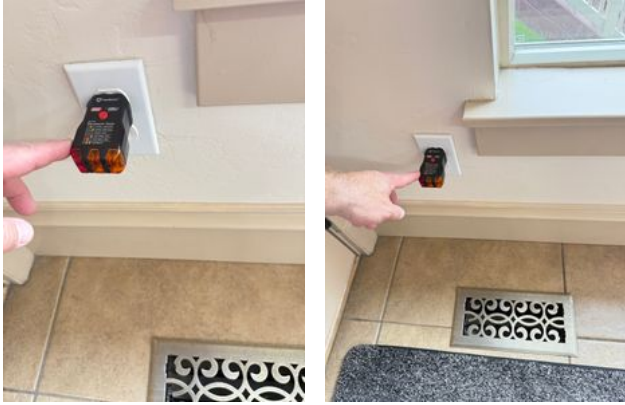
Defect: An electrical outlet tested positive for an "Open Hot" fault condition, indicating zero voltage is reaching the hot slot.

Implication: The outlet is completely dead and non-functional due to a broken internal wire connection, a loose wire nut, or an unmapped tripped breaker upstream.

Recommendation: Recommend troubleshooting and wire repair by a licensed electrician.

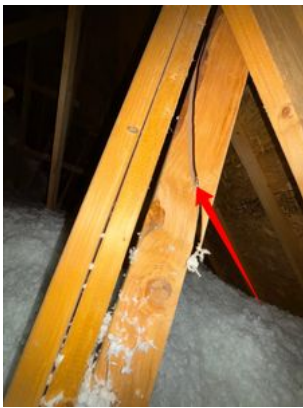
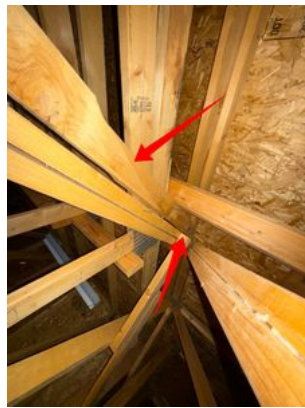
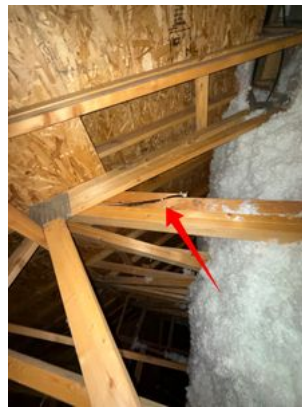
Defect: A structural roof truss or rafter has been cut, split, or modified.

Recommendation: HIGH PRIORITY: Recommend evaluation and structural repair by a licensed framing contractor or according to an engineer's design.

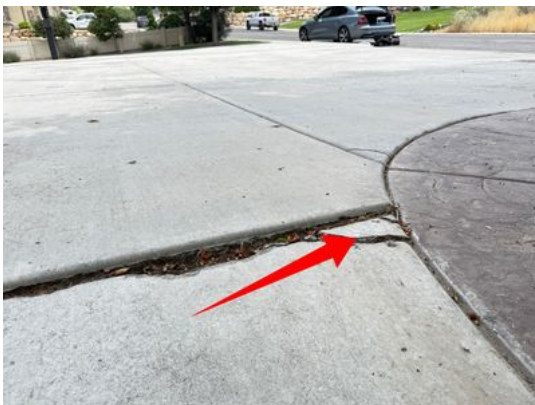
Defect: Exterior concrete walkway sections, driveway, or entry steps have visibly settled, tilted, or shifted out of position.

Implication: Creates a distinct physical tripping hazard and can alter exterior surface water runoff vectors back toward the foundation.

Recommendation: Recommend a concrete lifting specialist stabilize and raise the slabs via poly-jacking or mud-jacking.

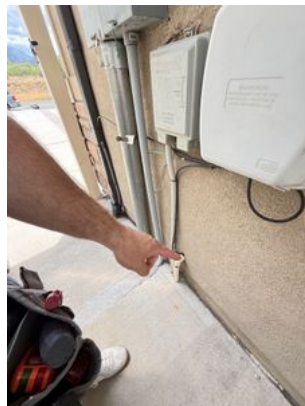
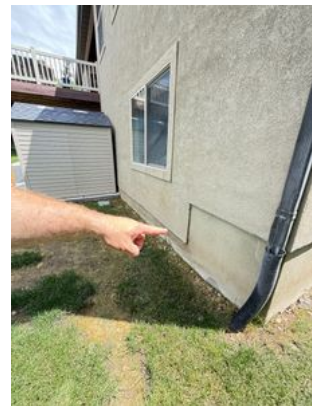
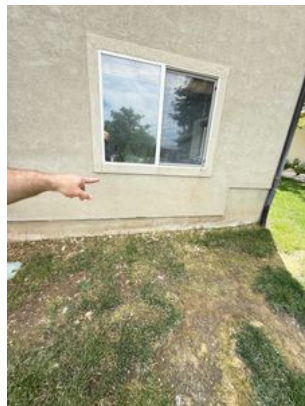
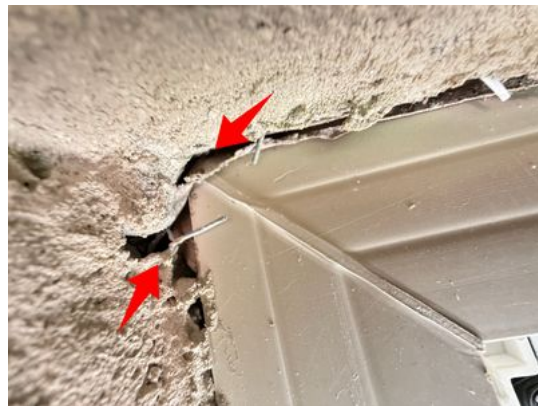
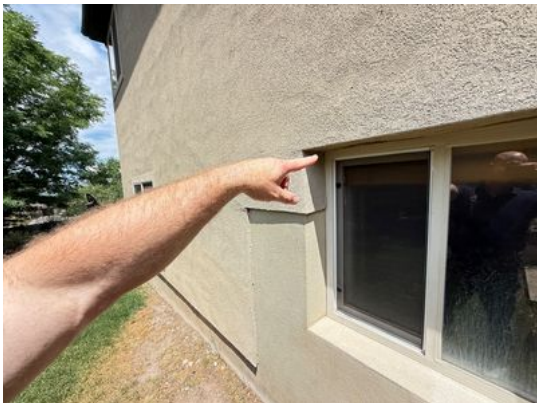
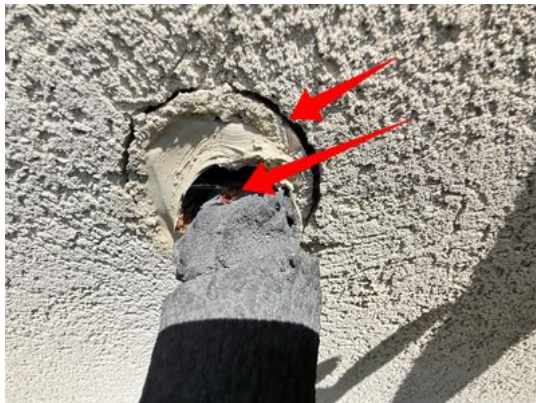
**Comment 6**

Small to moderate gaps were observed on the exterior of the home.

These gaps can allow moisture, pests, and debris to enter. Cracks are not necessarily structural defects.

The proper sealing of all cracks and gaps on the exterior is recommended.

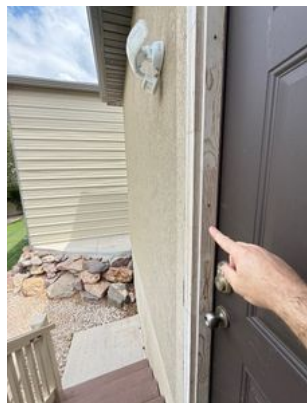
#### Comment 7

Worn paint (or worn stain) observed.

Paint protects and prolongs the life of the wood, metal and/or structure.

Sanding and repainting all worn areas is recommended.

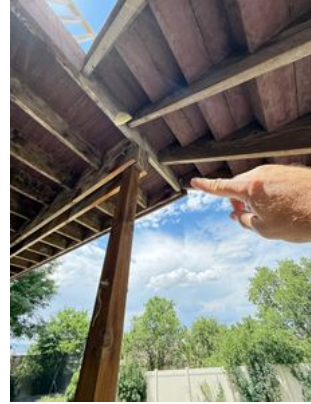
#### Comment 8

Missing Joist Hanger Fasteners or Wrong Kind of Fasteners

Defect: Deck joist hangers are installed using unapproved structural screws, missing double-shear angled fasteners, or have empty pre-punched holes.

Recommendation: HIGH PRIORITY: Require a licensed contractor to replace all improper fasteners with manufacturer-approved connector screws (e.g., Simpson Strong-Drive SD) or hot-dip galvanized common nails.

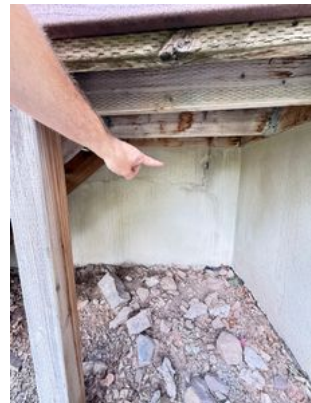
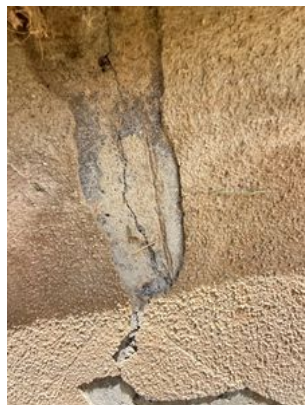
#### Comment 9

Hairline to moderate cracks were observed in the foundation wall.

Cracks may be superficial or extend through the foundation and are not necessarily structural; however, they may be associated with settling, material movement, or drying. Cracks can also allow water intrusion, which may lead to further damage.

Further evaluation by a qualified concrete or foundation contractor is recommended. Repairs may include sealing or epoxy injection, as appropriate.

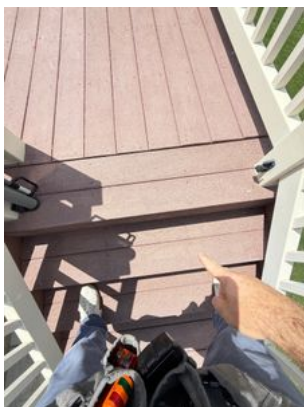
#### **Comment 10**

The staircase assembly was loose and wobbles from side to side. Additionally, no joist hangers or approved structural fasteners are present where the stair stringers meet the upper framing.

This indicates inadequate structural attachment and lateral support, presenting a severe fall and collapse hazard.

Recommend immediate evaluation and repair by a licensed framing contractor to properly secure the staircase.

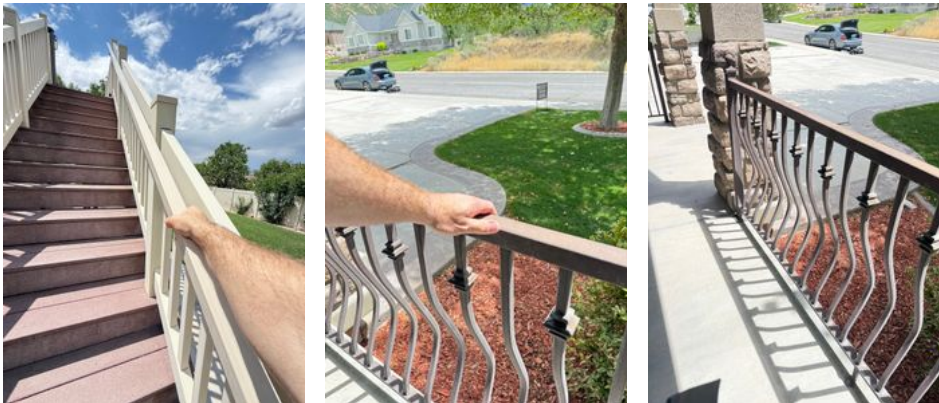
#### **Comment 11**

Defect: Handrails and/or guardrails were loose and exhibit movement.

Implication: Fall hazard; handrails must be completely rigid to withstand a minimum 200 lb concentrated load for occupant safety.

Recommendation: Recommend a qualified finish carpenter or specialist secure all loose mountings and brackets.

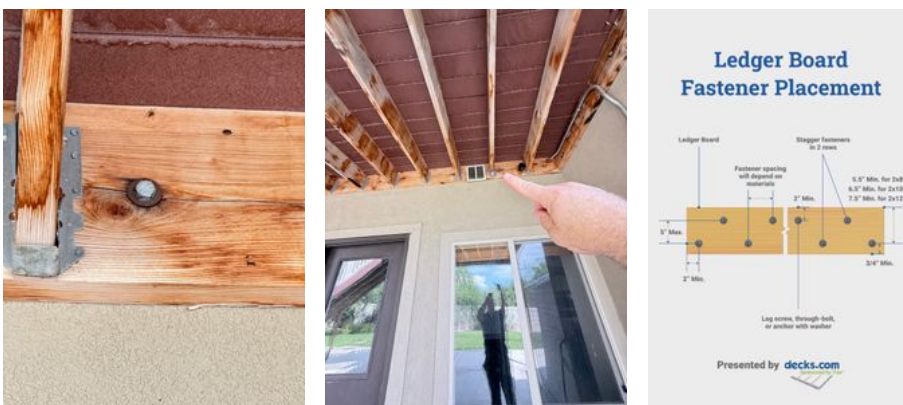
### Comment 12 Major Deficiencies

Defect: Structural deck ledger board is secured with undersized bolts, missing washers, or has lag spacing exceeding the 36-inch maximum zigzag pattern code limit.

Implication: The ledger board connection is the primary failure point for decks. Improper lag fastening can allow the entire deck structure to tear away from the home's house rim joist under load.

Recommendation: HIGH PRIORITY: Require a licensed framing contractor to install code-compliant 1/2-inch structural ledger lag screws with washers in a correct zigzag spacing matrix.

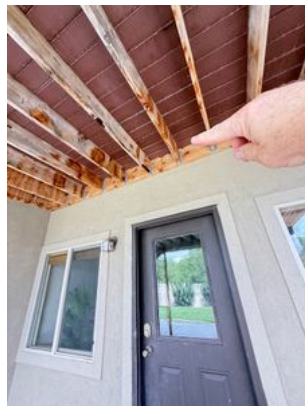
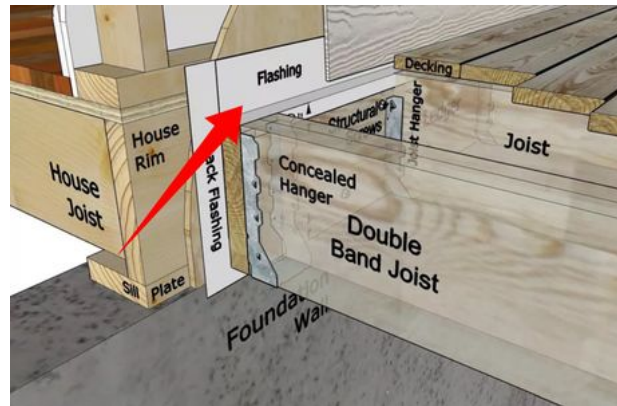
### Comment 13 Major Deficiencies

**Defect:** No metal Z-flashing or drip cap is installed at the horizontal material transition joint between the upper siding and lower siding.

**Implication:** The joint relies solely on sealant caulking, which degrades over time. Water will bypass the seal and run directly behind the lower siding, rotting the structural wall studs.

**Recommendation:** HIGH PRIORITY: Recommend a qualified siding contractor retro-fit an integrated metal drip cap flashing into the building wrap barrier. There should be flashing when two different types of siding meet.

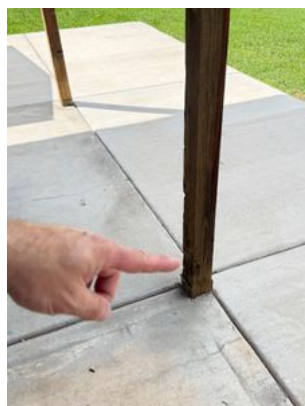
### Comment 14

**Defect:** Structural joist hanger nails or post bracket fasteners are missing, backing out, or were driven at incorrect angles.

**Recommendation:** Recommend driving in all backed-out nails or adding approved manufacturer-specific structural connector fasteners into empty holes.

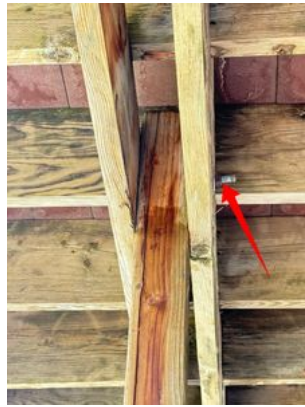
#### Comment 15

1. Observation: The main deck framing (rim joist/beam) is currently flush-bolted to the sides of the vertical support posts rather than resting directly on top of them. This creates a condition where the entire structural load of the deck relies purely on the shear strength of the fasteners (bolts) rather than direct, gravity-loaded bearing on the posts.

2. 4 x 4 posts were used to support the deck. The deck appeared to be a little taller than 8 feet, in which case 6 x 6 posts, would be the standard. In addition, one of the posts was bowed. It is recommended to have this deck evaluated by a deck specialist and repaired.

Recommendation: A qualified licensed contractor should evaluate the structure and install approved post-to-beam connectors, structural brackets, or vertical jack studs (shims/blocks) to ensure positive, direct load transfer from the deck framing down to the footings.

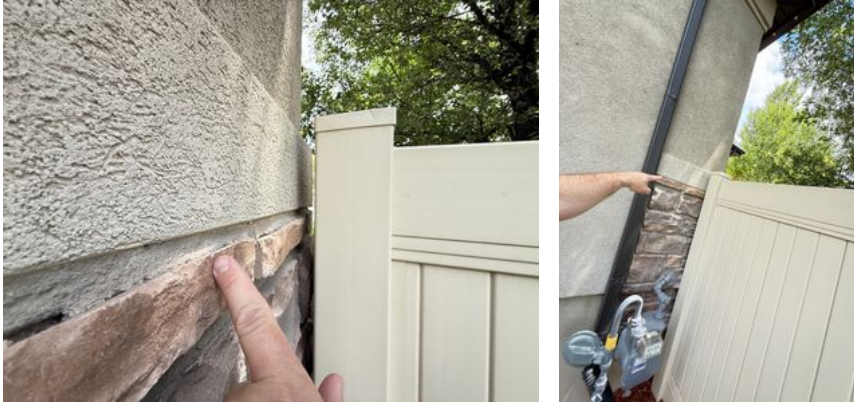
#### Comment 16

Z-Flashing Missing for Transition of Two Different Siding Materials

Recommendation: HIGH PRIORITY: Recommend a qualified siding contractor retro-fit an integrated metal drip cap flashing into the building wrap barrier. There should be flashing when two different types of siding meet.

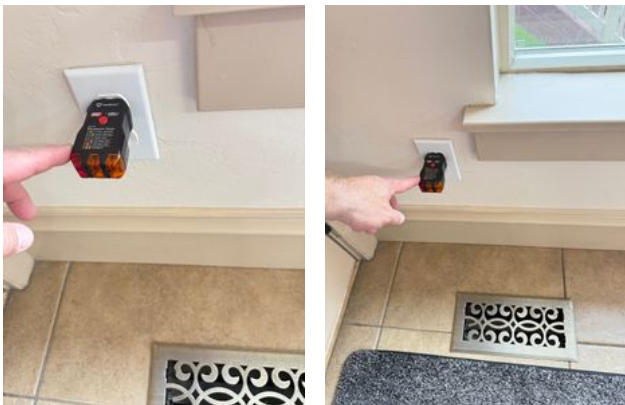
### **Comment 27** **Safety Hazards**

Electrical Receptacle Open Hot

Recommendation: Recommend troubleshooting and wire repair by a licensed electrician.
