**Illuminate Home Inspections**

## Home Inspection Report

751 East 650 South  
Santaquin, UT 84655

Inspected on Sat, Jul 18, 2026 at 1:30 PM

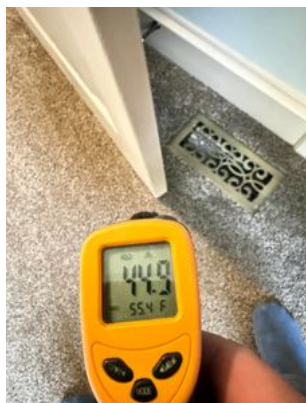
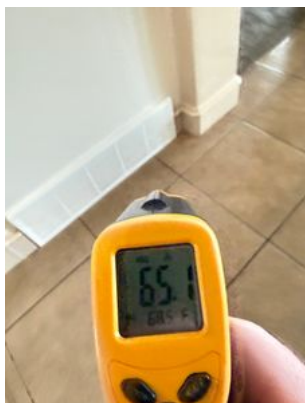
Temperature split between return vent and supply registers (Delta T) noted:  
20.2 degrees F.

A good range is at least 15 - 20 degrees F difference.

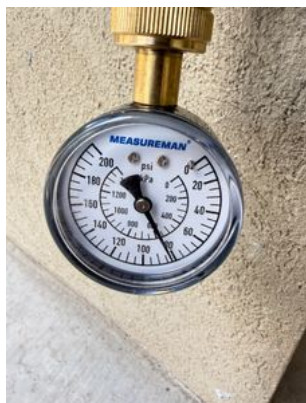
Hose bib water pressure.

A good range for plumbing pressure:40-80 psi.

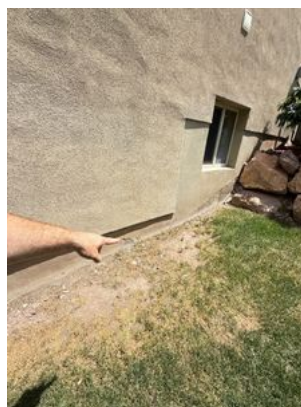
Hairline to moderate cracks were observed in the foundation wall.

Cracks may be superficial or extend through the foundation and are not necessarily structural; however, they may be associated with settling, material movement, or drying. Cracks can also allow water intrusion, which may lead to further damage.

Further evaluation by a qualified concrete or foundation contractor is recommended. Repairs may include sealing or epoxy injection, as appropriate.

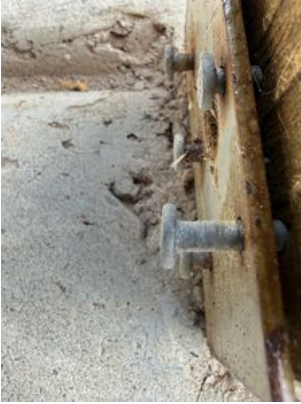
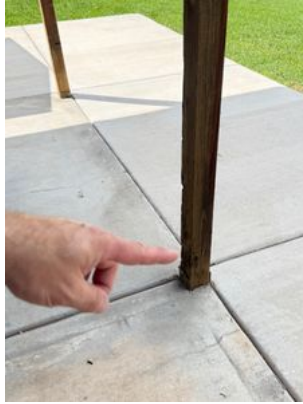
Defect: Structural joist hanger nails or post bracket fasteners are missing, backing out, or were driven at incorrect angles.

Implication: Compromises the full weight load transfer capacity of the structural wood connectors, potentially causing localized floor or deck sagging.

Recommendation: Recommend driving in all backed-out nails or adding approved manufacturer-specific structural connector fasteners into empty holes.

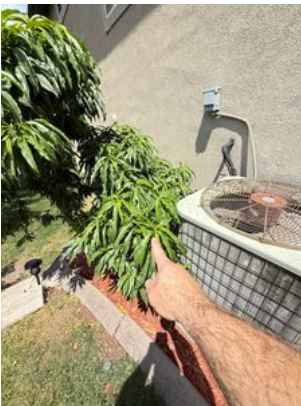
Air Conditioner Condenser: The exterior AC condenser unit lacks sufficient clearance around it to allow for adequate airflow and proper operation.

Recommend maintaining a minimum of 12–18 inches of clear space around the unit and contacting a licensed HVAC technician to evaluate for potential performance or longevity issues.

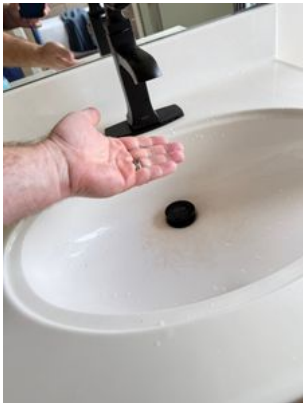
Multiple Fixture Plumbing Pressure Drop

Defect: Running multiple plumbing fixtures simultaneously results in a drop in operational water pressure and flow.

Implication: Indicates underlying issues such as undersized main water lines, heavily corroded/scaled galvanized piping, a failing pressure regulator (PRV), or a partially closed water main valve.

Recommendation: Recommend a licensed plumber inspect the incoming supply loop and verify system pressure.

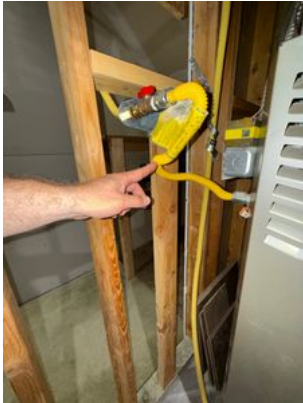
### Gas Supply Line Missing Sediment Trap

Defect: No vertical plumbing sediment trap (drip leg assembly) is provided on the rigid gas supply pipe line right before it terminates at the appliance gas valve.

Implication: Violates standard gas codes. Fails to catch moisture condensation, pipe scale, and black iron manufacturing debris before it travels into the sensitive automated gas control valves, jamming them open or closed.

Recommendation: Recommend a licensed plumber or HVAC technician retrofit a standard tee-and-cap sediment trap on the appliance gas feed line.

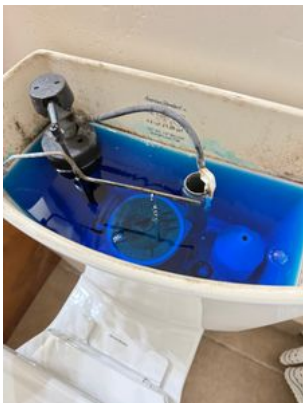
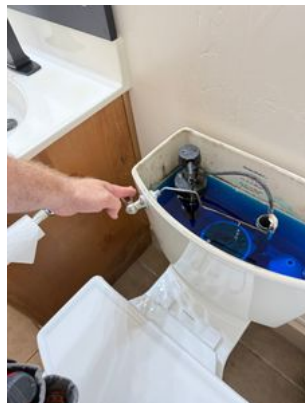
### Plumbing Toilet Operating Handle Malfunction

Defect: The exterior flush handle on the toilet tank was loose, sticks down, or fails to activate the flush mechanism.

Implication: Causes the internal flush valve flapper to remain stuck open, resulting in a continuous water run that fills the sewer line and spikes utility bills.

Recommendation: Recommend adjusting or replacing the internal toilet tank lift chain and handle rod.

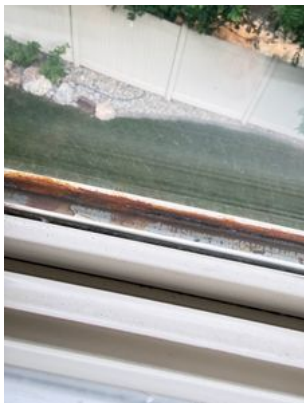
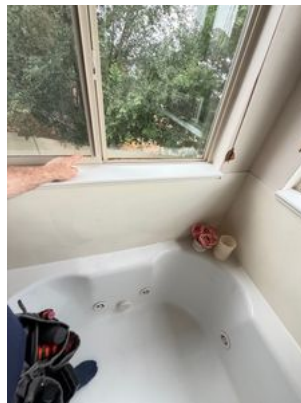
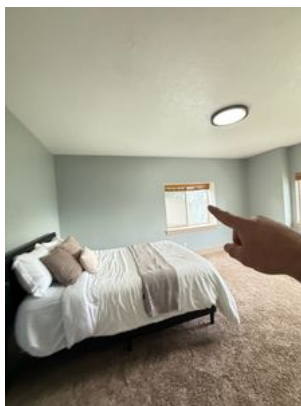
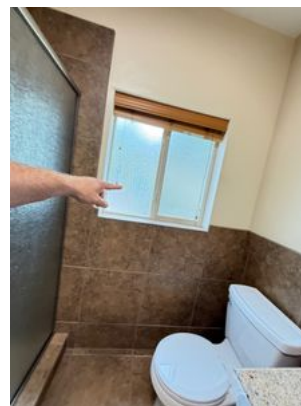
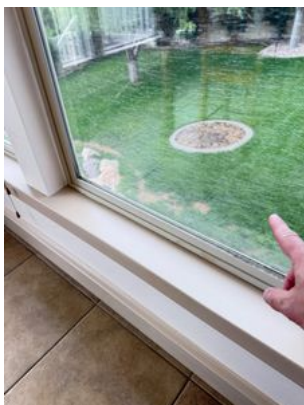
The weather seal at the window was broken. Broken seal or moisture between the panes.

This can affect the home's energy efficiency. It can also potentially cause moisture to seep into the structure of the home.

Have a qualified specialist evaluate and seal the gap to ensure a weather-tight finish.

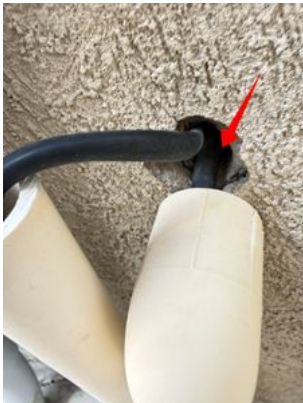
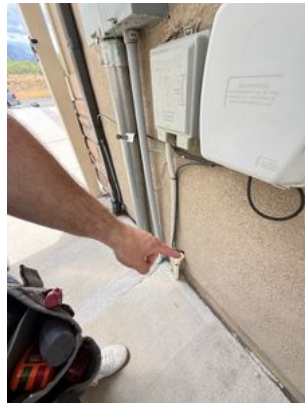
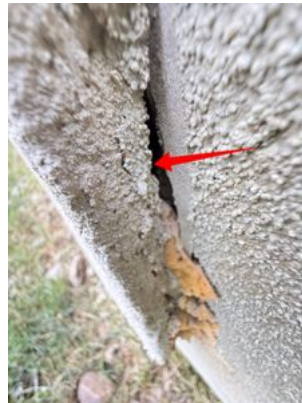
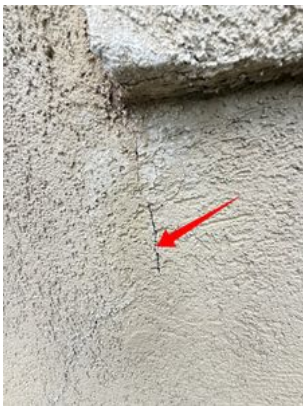
Small to moderate gaps were observed on the exterior of the home.

These gaps can allow moisture, pests, and debris to enter. Cracks are not necessarily structural defects.

The proper sealing of all cracks and gaps on the exterior is recommended.

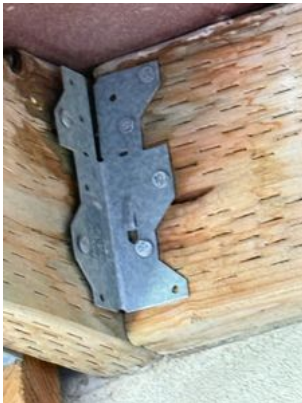
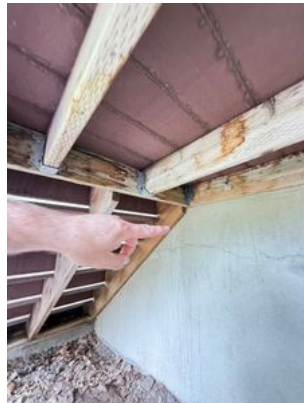
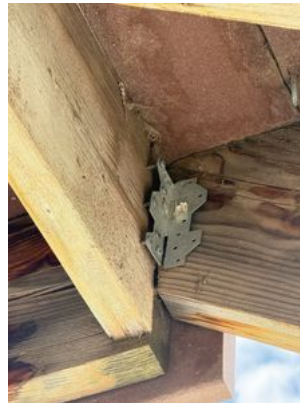
#### Missing Joist Hanger Fasteners or Wrong Kind of Fasteners

Defect: Deck joist hangers are installed using unapproved structural screws, missing double-shear angled fasteners, or have empty pre-punched holes.

Implication: Non-approved fasteners lack the necessary shear strength. Under heavy live loads (like snow or gatherings), the joists can shear off the ledger board, causing total deck collapse.

Recommendation: HIGH PRIORITY: Require a licensed contractor to replace all improper fasteners with manufacturer-approved connector screws (e.g., Simpson Strong-Drive SD) or hot-dip galvanized common nails.

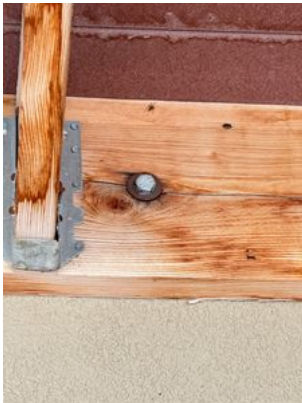
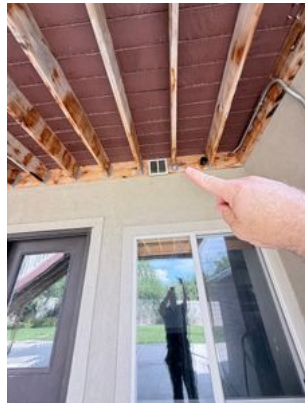
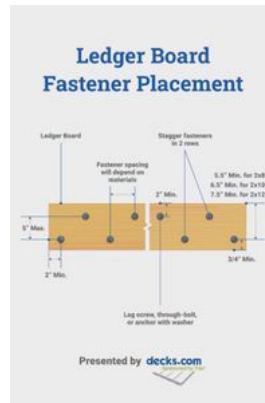
#### Deck Ledger Board Inadequate Fastening

Defect: Structural deck ledger board is secured with undersized bolts, missing washers, or has lag spacing exceeding the 36-inch maximum zigzag pattern code limit.

Implication: The ledger board connection is the primary failure point for decks. Improper lag fastening can allow the entire deck structure to tear away from the home's house rim joist under load.

Recommendation: HIGH PRIORITY: Require a licensed framing contractor to install code-compliant 1/2-inch structural ledger lag screws with washers in a correct zigzag spacing matrix.

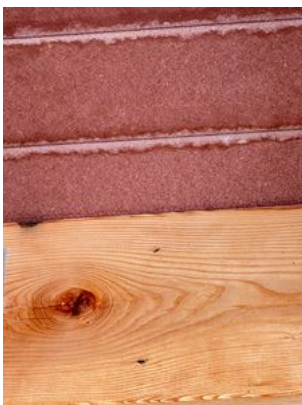
#### Z-Flashing Missing for Transition of Two Different Siding Materials

Defect: No metal Z-flashing or drip cap is installed at the horizontal material transition joint between the upper siding and lower siding.

Implication: The joint relies solely on sealant caulking, which degrades over time. Water will bypass the seal and run directly behind the lower siding, rotting the structural wall studs.

Recommendation: HIGH PRIORITY: Recommend a qualified siding contractor retro-fit an integrated metal drip cap flashing into the building wrap barrier. There should be flashing when two different types of siding meet.

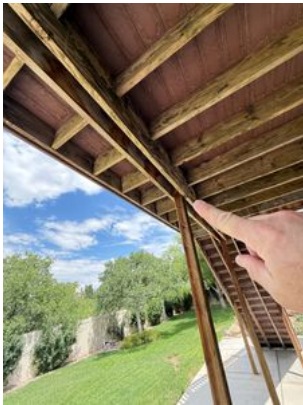
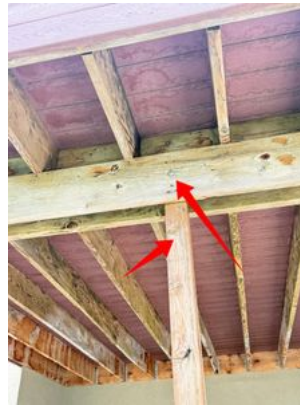
1. Observation: The main deck framing (rim joist/beam) is currently flush-bolted to the sides of the vertical support posts rather than resting directly on top of them. This creates a condition where the entire structural load of the deck relies purely on the shear strength of the fasteners (bolts) rather than direct, gravity-loaded bearing on the posts.

2. 4 x 4 posts were used to support the deck. The deck appeared to be a little taller than 8 feet, in which case 6 x 6 posts, would be the standard. In addition, one of the posts was bowed. It is recommended to have this deck evaluated by a deck specialist and repaired.

**Recommendation:** A qualified licensed contractor should evaluate the structure and install approved post-to-beam connectors, structural brackets, or vertical jack studs (shims/blocks) to ensure positive, direct load transfer from the deck framing down to the footings.

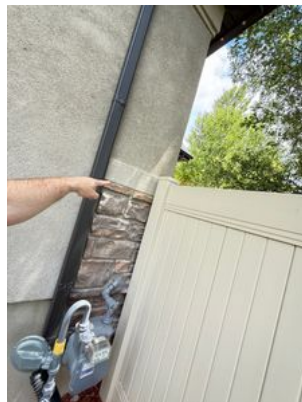
#### Z-Flashing Missing for Transition of Two Different Siding Materials

**Defect:** No metal Z-flashing or drip cap is installed at the horizontal material transition joint between the upper siding and lower siding.

**Implication:** The joint relies solely on sealant caulking, which degrades over time. Water will bypass the seal and run directly behind the lower siding, rotting the structural wall studs.

**Recommendation:** HIGH PRIORITY: Recommend a qualified siding contractor retro-fit an integrated metal drip cap flashing into the building wrap barrier. There should be flashing when two different types of siding meet.

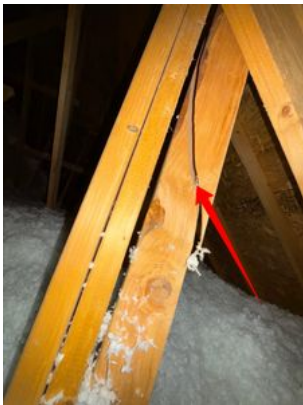
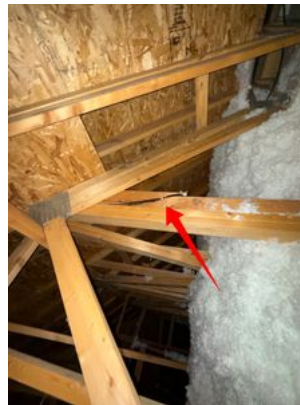
Defect: A structural roof truss or rafter has been cut, split, or modified.

Implication: Structural roof components are engineered systems; any unauthorized cuts drastically reduce their load capacity, risking roof sagging under heavy snow loads.

Recommendation: HIGH PRIORITY: Recommend evaluation and structural repair by a licensed framing contractor or according to an engineer's design.

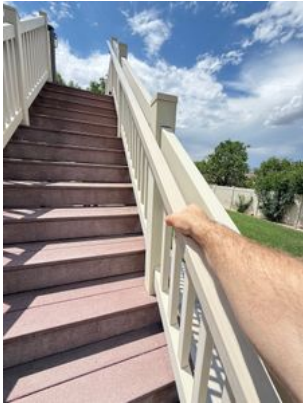
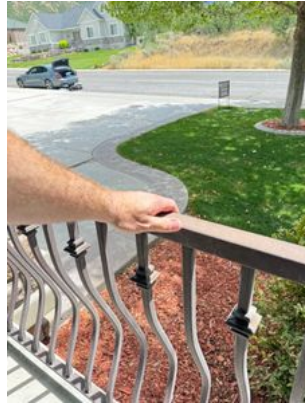
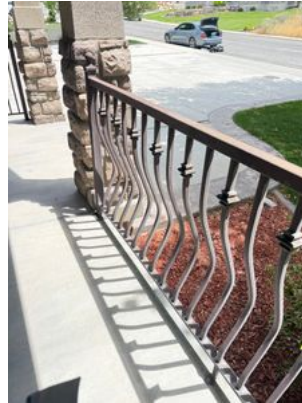
Defect: Handrails and/or guardrails were loose and exhibit movement.

Implication: Fall hazard; handrails must be completely rigid to withstand a minimum 200 lb concentrated load for occupant safety.

Recommendation: Recommend a qualified finish carpenter or specialist secure all loose mountings and brackets.

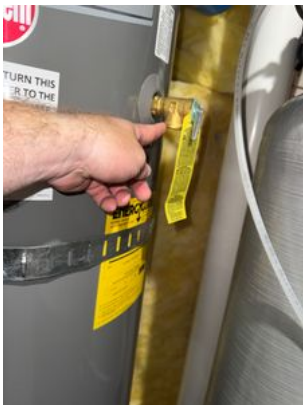
#### Water Heater TPR Discharge Pipe Missing

Defect: Temperature and Pressure Relief (TPR) safety valve lacks a discharge extension tube or terminated too high above the floor plane.

Implication: If the water heater overpressurizes or overheats, scalding water will violently blast outward horizontally, creating a severe burn hazard for anyone nearby.

Recommendation: HIGH PRIORITY: Require a licensed plumber to install an unthreaded rigid discharge extension pipe ending within 6 inches of the floor or draining to a pan.

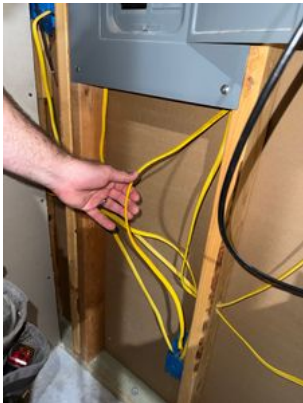
Wiring not secured. Have secured to protect the wires from being pulled. Potential safety issue.

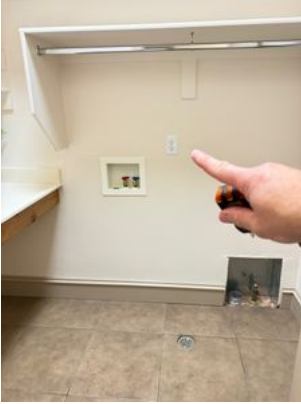
One more outlets were missing GFCI protection or the GFCI device did not function.

GFCI stands for ground fault circuit interrupter. It protects people from shock. This is a safety hazard. It is recommended to have a licensed electrician install GFCI protection in all wet and exterior areas of the home.

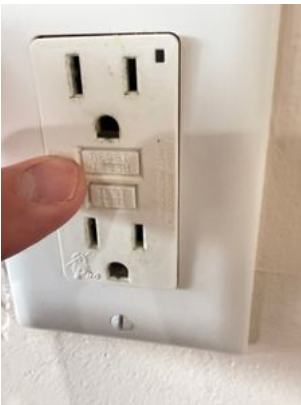
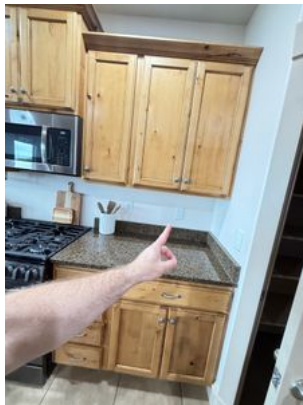
The GFCI outlet button was stuck and did not reset. GFCI protects against shock. Repair is recommended.

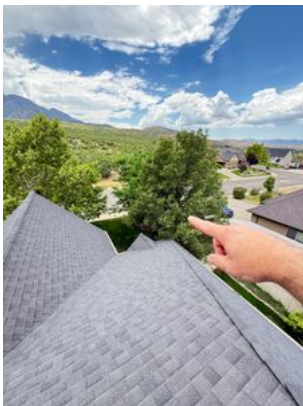
Trees with limbs contacting or overhanging the roof are recommended to be trimmed back or removed. Such conditions can allow pest access to the roof, increase the risk of roof damage from falling limbs, and contribute to gutter blockage from leaf debris.

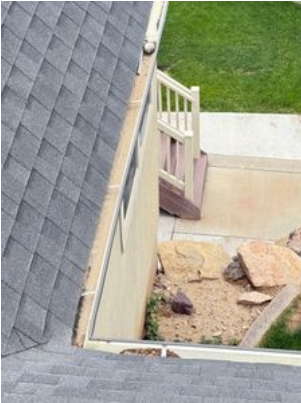
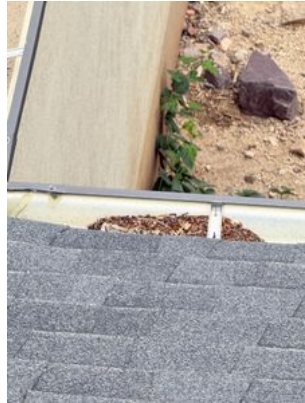
Defect: Debris observed in the gutters.

Implication: Debris in gutters hinders the flow and drainage of rainwater.

Recommendation: Cleaning the gutters is recommended.

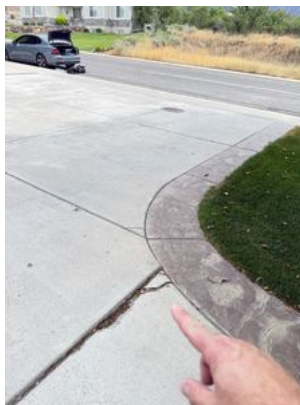
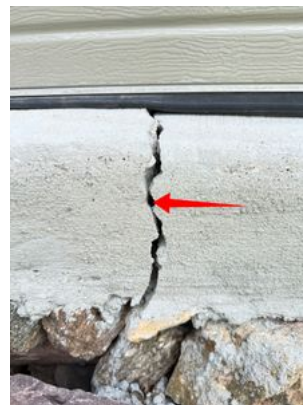
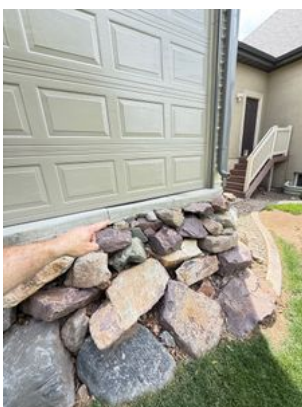
Defect: Exterior concrete walkway sections, driveway, or entry steps have visibly settled, tilted, or shifted out of position.

Implication: Creates a distinct physical tripping hazard and can alter exterior surface water runoff vectors back toward the foundation.

Recommendation: Recommend a concrete lifting specialist stabilize and raise the slabs via poly-jacking or mud-jacking.

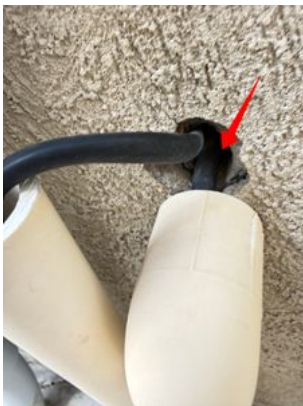
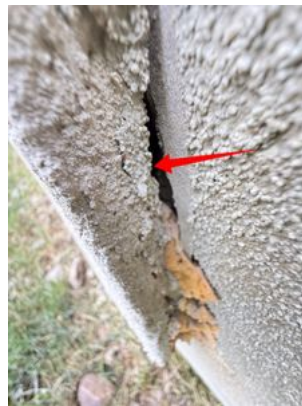
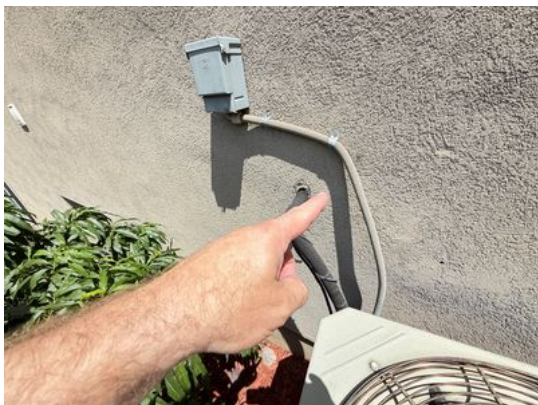
Small to moderate gaps were observed on the exterior of the home.

These gaps can allow moisture, pests, and debris to enter. Cracks are not necessarily structural defects.

The proper sealing of all cracks and gaps on the exterior is recommended.

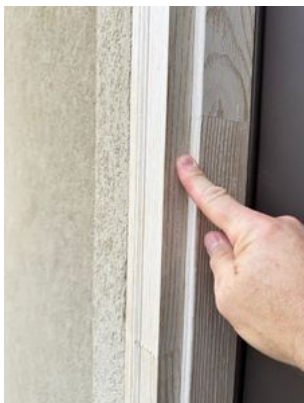
Worn paint (or worn stain) observed.

Paint protects and prolongs the life of the wood, metal and/or structure.

Sanding and repainting all worn areas is recommended.

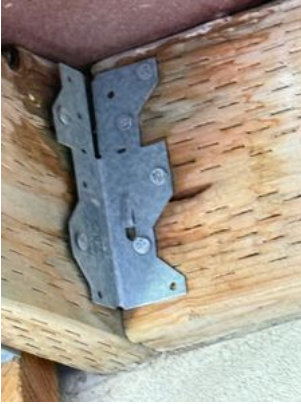
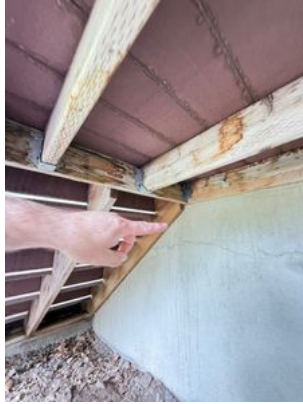
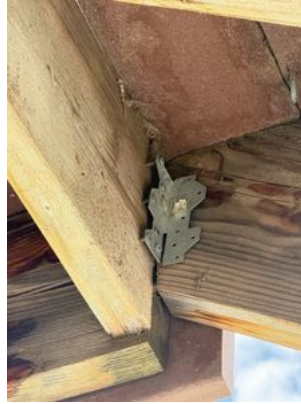
Implication: Non-approved fasteners lack the necessary shear strength. Under heavy live loads (like snow or gatherings), the joists can shear off the ledger board, causing total deck collapse.

Recommendation: HIGH PRIORITY: Require a licensed contractor to replace all improper fasteners with manufacturer-approved connector screws (e.g., Simpson Strong-Drive SD) or hot-dip galvanized common nails.

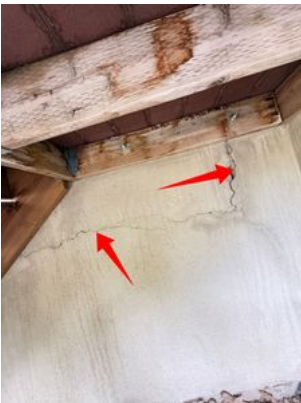
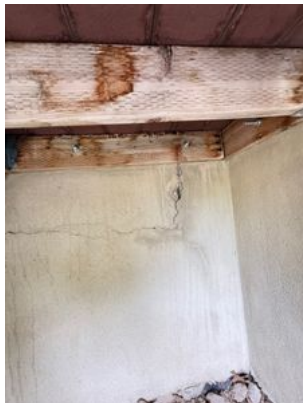
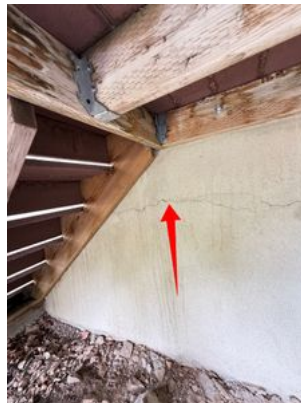
#### Comment 9

Hairline to moderate cracks were observed in the foundation wall.

Cracks may be superficial or extend through the foundation and are not necessarily structural; however, they may be associated with settling, material movement, or drying. Cracks can also allow water intrusion, which may lead to further damage.

Further evaluation by a qualified concrete or foundation contractor is recommended. Repairs may include sealing or epoxy injection, as appropriate.

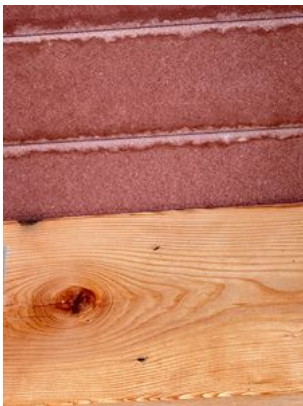
### Comment 13 Major Deficiencies

#### Z-Flashing Missing for Transition of Two Different Siding Materials

**Defect:** No metal Z-flashing or drip cap is installed at the horizontal material transition joint between the upper siding and lower siding.

**Implication:** The joint relies solely on sealant caulking, which degrades over time. Water will bypass the seal and run directly behind the lower siding, rotting the structural wall studs.

**Recommendation:** HIGH PRIORITY: Recommend a qualified siding contractor retro-fit an integrated metal drip cap flashing into the building wrap barrier. There should be flashing when two different types of siding meet.

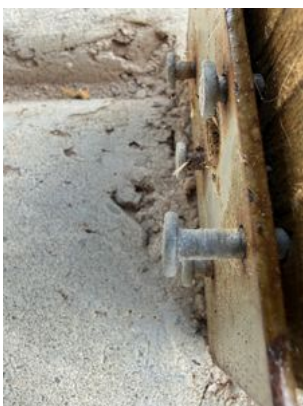
### Comment 14

**Defect:** Structural joist hanger nails or post bracket fasteners are missing, backing out, or were driven at incorrect angles.

**Implication:** Compromises the full weight load transfer capacity of the structural wood connectors, potentially causing localized floor or deck sagging.

**Recommendation:** Recommend driving in all backed-out nails or adding approved manufacturer-specific structural connector fasteners into empty holes.

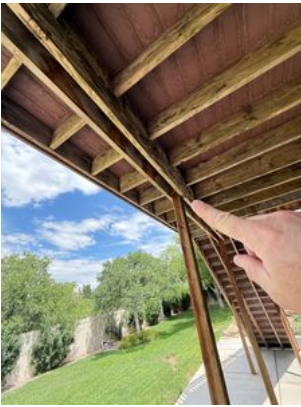
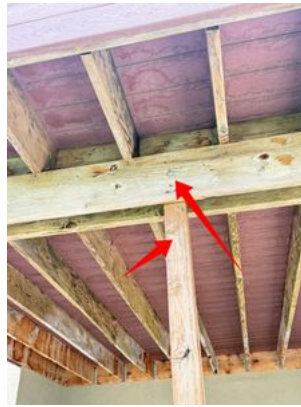
#### Comment 15

1. Observation: The main deck framing (rim joist/beam) is currently flush-bolted to the sides of the vertical support posts rather than resting directly on top of them. This creates a condition where the entire structural load of the deck relies purely on the shear strength of the fasteners (bolts) rather than direct, gravity-loaded bearing on the posts.

2. 4 x 4 posts were used to support the deck. The deck appeared to be a little taller than 8 feet, in which case 6 x 6 posts, would be the standard. In addition, one of the posts was bowed. It is recommended to have this deck evaluated by a deck specialist and repaired.

Recommendation: A qualified licensed contractor should evaluate the structure and install approved post-to-beam connectors, structural brackets, or vertical jack studs (shims/blocks) to ensure positive, direct load transfer from the deck framing down to the footings.

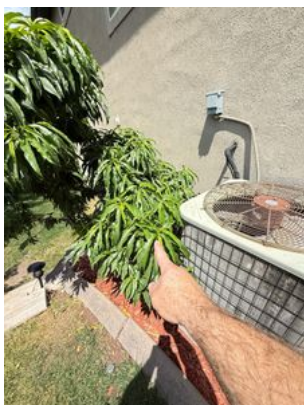
Air Conditioner Condenser: The exterior AC condenser unit lacks sufficient clearance around it to allow for adequate airflow and proper operation.

Recommend maintaining a minimum of 12–18 inches of clear space around the unit and contacting a licensed HVAC technician to evaluate for potential performance or longevity issues.

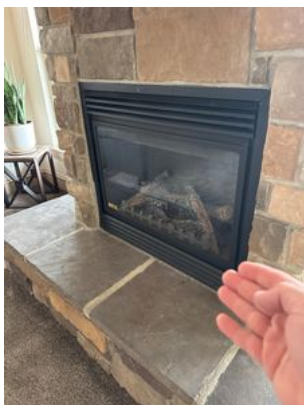
### Comment 19 Information

Fireplace was not operating with normal controls at the time of the inspection. Or remote is missing. Have the seller demonstrate that the fireplace is working.

Sometimes, the pilot or valve is turned off. The inspector does not relight pilots or turn on gas valves that are off for liability reasons.

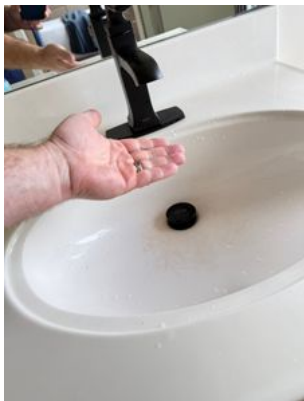
#### Comment 21

Defect: Running multiple plumbing fixtures simultaneously results in a drop in operational water pressure and flow.

Implication: Indicates underlying issues such as undersized main water lines, heavily corroded/scaled galvanized piping, a failing pressure regulator (PRV), or a partially closed water main valve.

Recommendation: Recommend a licensed plumber inspect the incoming supply loop and verify system pressure.

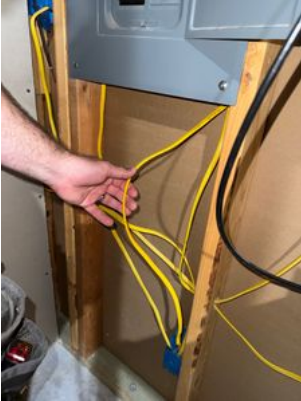
Wiring not secured. Have secured to protect the wires from being pulled. Potential safety issue.

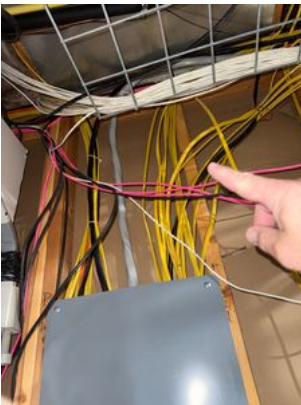
**Comment 29**

Wires from a panel were not secured within 12 inches of the panel.

Correction by a licensed electrician is recommended.

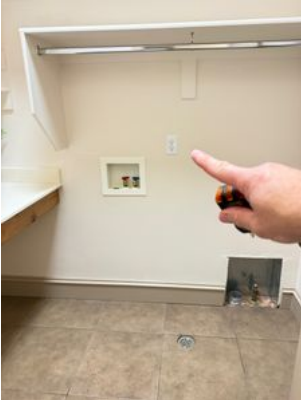
**Comment 30**

One more outlets were missing GFCI protection or the GFCI device did not function.

GFCI stands for ground fault circuit interrupter. It protects people from shock. This is a safety hazard. It is recommended to have a licensed electrician install GFCI protection in all wet and exterior areas of the home.

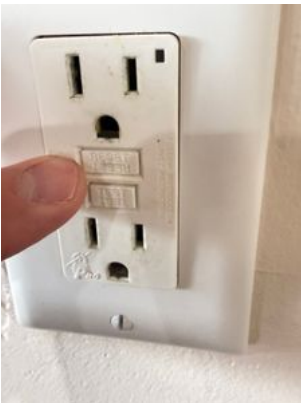
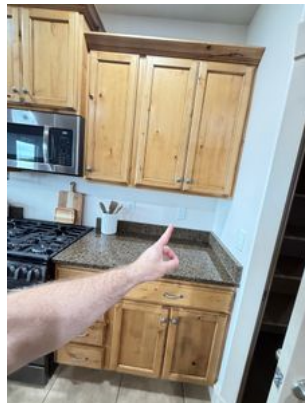
### **Comment 31** **Safety Hazards**

The GFCI outlet button was stuck and did not reset. GFCI protects against shock. Repair is recommended.

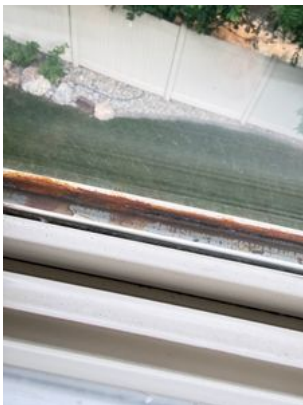
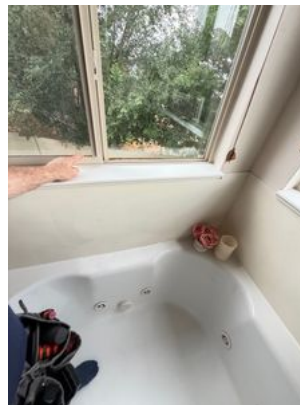
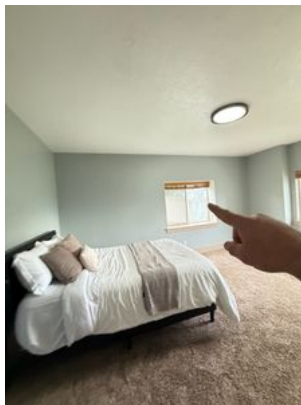
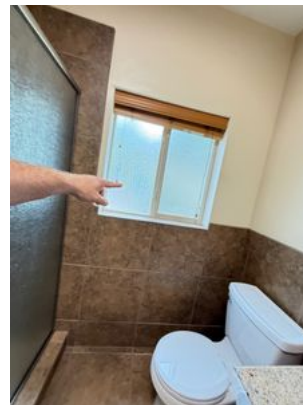
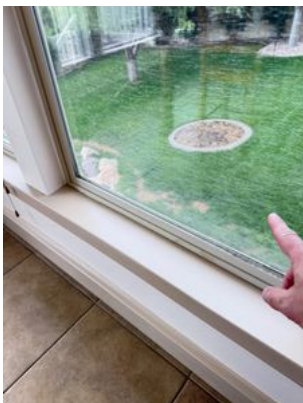
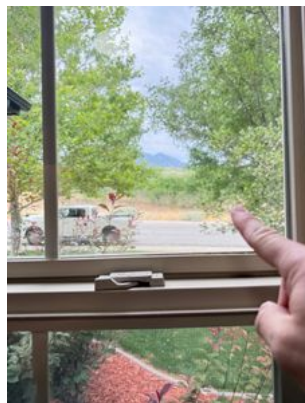
The weather seal at the window was broken. Broken seal or moisture between the panes.

This can affect the home's energy efficiency. It can also potentially cause moisture to seep into the structure of the home.

Have a qualified specialist evaluate and seal the gap to ensure a weather-tight finish.
